Creaking Joints.

Phil Buckley, ATFA Inspector, Mint Floors & Shutters.

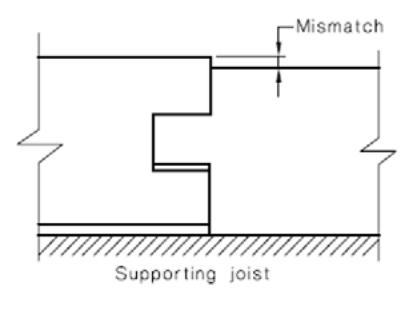
(a) Mismatch

AS2796.1 (Timber – Hardwood – Sawn and milled products, Part 1: Product Specification) has quite detailed tolerances for the side profiling of both face fixed and secret nail profiled boards; but end joints are less specifically controlled. Generally, the 0.5mm mismatch tolerance is the standard used when assessing an end joint.

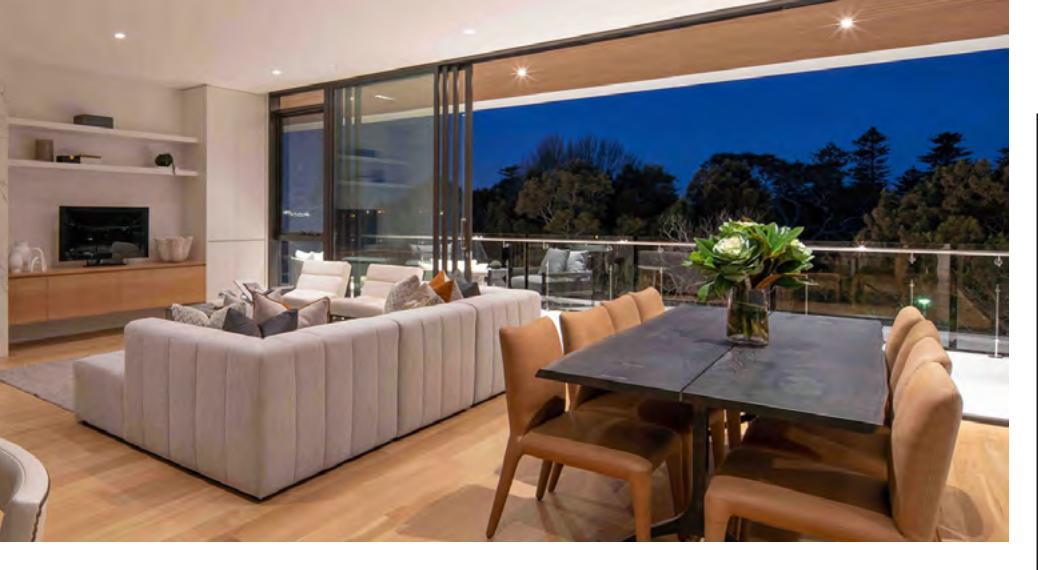
However, there will be times when there is no budget or height to fit a sheet of plywood or particleboard between the joists/ battens and the flooring, exposing us to this end joint movement risk. In fact, Mint completed an installation in 2021 where this very problem raised its head – with 400m² of 130mm American White Oak over 8 ground floor apartments!

The installation team noticed movement on many end joints and the works were halted while we investigated. The manufacturer of the boards attended site and all end joints were found to be within the tolerances (noting that American White Oak is not actually constrained by the Australian Standards anyway) and that there were no reasons (or time) to recall the boards. At this stage, we had installed 4 of the 8 units (or about 200m² of flooring).

The results 18 months down the road? We have attended site 7 times to remediate squeaking end joints on the first 4 units installed (with no PVA), with variable success and at considerable cost. We have had no claims at all lodged against the floors with PVA end joints. Not only that, but sunlight has also caused some shrinkage in all units, with units with the PVA end joints having no edge bonding as a result of the adhesive at all – noting that we did take care to ensure we did not extend the adhesive down the sides of the boards.

To help mitigate the risk, I instructed the team to start applying PVA adhesive to the end joints of all boards for the remainder of the ground floor units.

As a result of this simple and very effective risk mitigation, Mint Floors now has a standing instruction that ALL floors installed over joists or battens have a cross-linked PVA applied to all end joints. We have not had a single complaint raised on moving end joints since.
