Brighton Project

atfa | timber floors

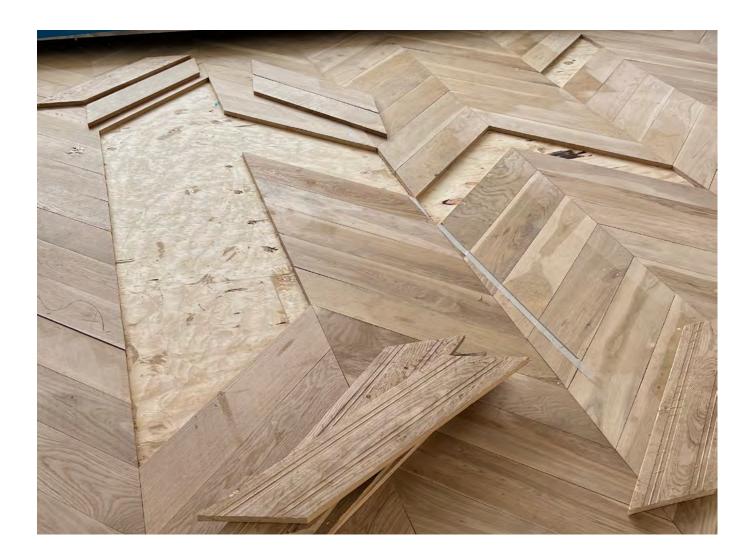
The issues began with the way the Oak parquetry was installed. Blocks had been laid over the glue after a skin had formed, resulting in many of the parquetry blocks adhering poorly to the subfloor and moving upon standing. To remedy this issue, the affected blocks were removed, substrate and blocks cleaned ready to be reinstall following correct process.

The next issue we encountered was that some blocks were stuck down too hard, which made their removal without breakage extremely tricky. Others had moving corners creating squeaks as the floor was walked over – which we corrected by drilling small 2mm holes through the parquetry blocks and applying a raising polyurethane glue injection to fill the void and create a solid block ready for sanding.

Additionally, the laser cut edges had not been installed in a straight line so that one end was tight while the other end had up to a 1-2mm gap. This was further compounded by the timber being wet on installation and when the home climate control was activated, the entire floor shrunk 2mm – making some of the gaps 3-4mm around the entire block and over the entire floor.

We made random examination of the environment and moisture content to ensure the flooring had stabilised after 6 months of being down. The residual gaps were filled with almost 60 kilos of timber wood floor filler. This was not watered down, but manually pushed in to ensure the filler penetrated as deeply as possible to achieve greater stability.

Once the floor was stable and ready to sand, I had the issue of colour as the previous company had attempted a white wash in a room upstairs, which had turned the Oak yellow, presumably due to the tannin and oils in the timber itself. With this in mind, we opted to work with our custom colours and create a look that would match the tones in the marble work downstairs. Multiple colours were attempted but everything we tried kept producing a yellow undertone as we were using such light colours. We finally decided to apply a very diluted black stain directly to the timber – almost the colour of dirty water – in an attempt to counteract the yellow note in the timber itself. This allowed us to achieve the final desired tan colour.

Once the stain was complete, a waterborne polyurethane coating was applied with specific amounts of white added into each coat to achieve the final tan colour – being very similar to the natural colour of the timber itself this brought a perfect harmony between the timber and the marble within the home.
