Project profile...

Old Parliament House

A fire in December 2021 left the flooring of the front foyer of Old Parliament House irretrievably damaged. Last sanded in 2011, the floor was a bespoke pattern of Jarrah parquet and Mountain Ash borders.

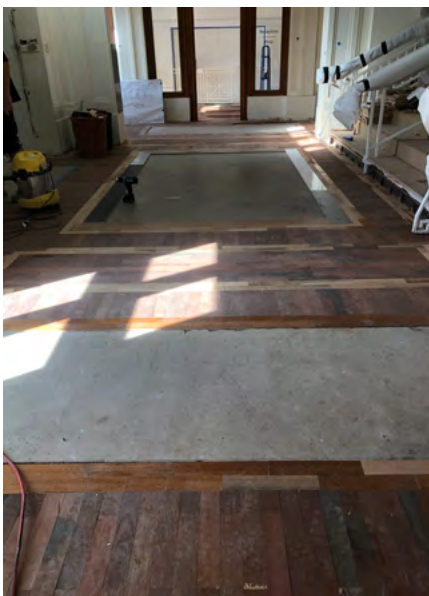
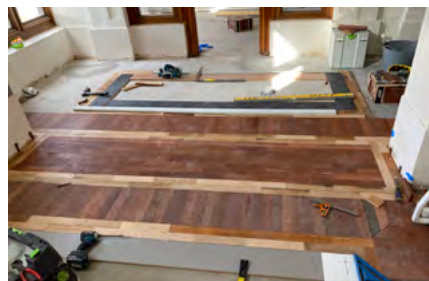
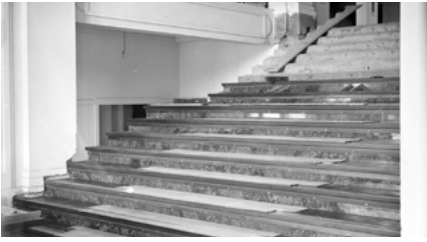
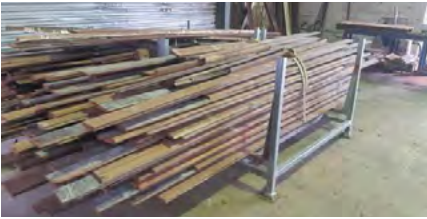
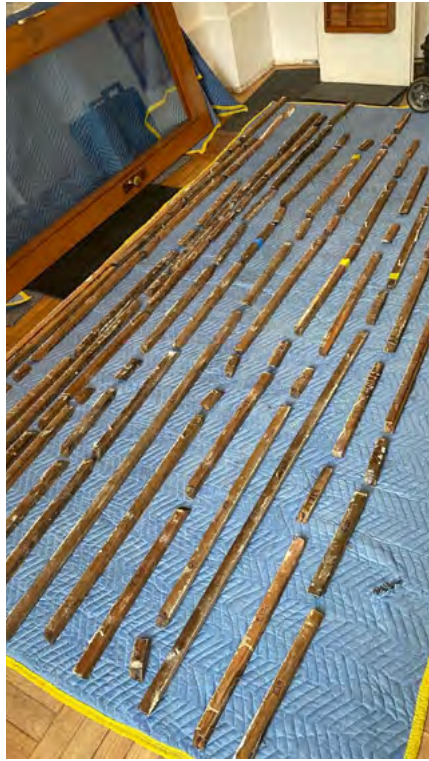
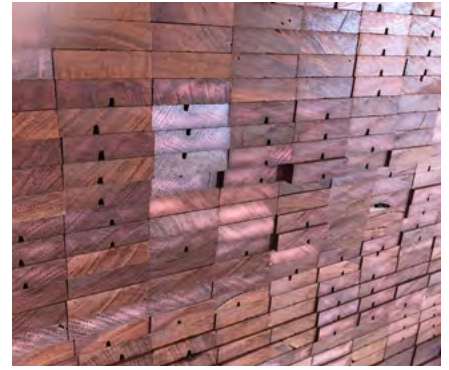
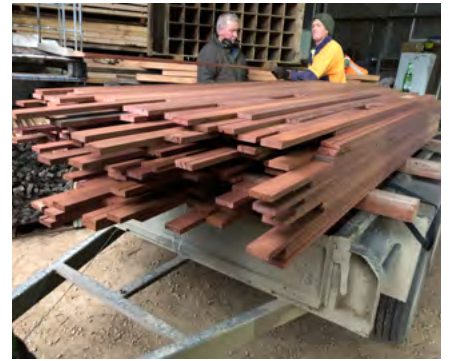
An eagle-eyed observer may notice some anomalies. There are mitred joints in some areas and not others, boards of varying widths and lengths in random areas, and some border flows that seem anachronistic. While counterintuitive to installers of new floors, it was critical to recreating something that once was. The entire section was trowel glued with Soudal SMX 30+.

Preparation and sealing of the floor was undertaken by Refined Flooring and Old2New Timber Flooring. Traditionally, we would trowel fill parquet to provide greater stability and a mirror surface; however, it was decided to forgo the trowelling in a bid to help 'age' the area, as the original installation hadn't been trowelled either. The floor was sealed with Bona Traffic HD anti-slip as it is directly accessed by an outside door.
